# SWAG 10 92 6775

to fit:  
Mercedes Benz CDI engines

Repl. No. 646 200 05 70

## Belt tensioner

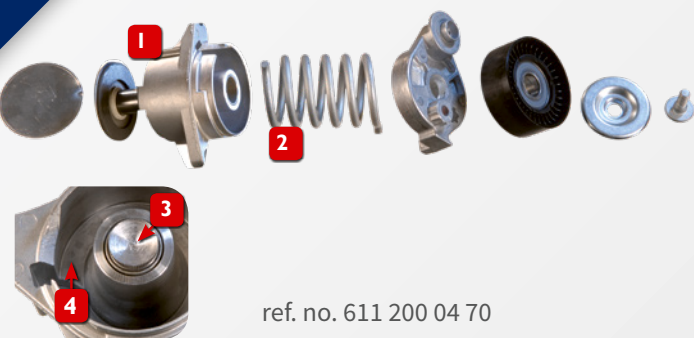
ref. no. 611 200 04 70

The noise is generated because the spring is too long and makes direct contact with the base of the housing (1). Only the spring's torsional characteristics are important for this application (2), (6).

The noise is caused when the spring touches the cast-in hollow pin (3) and the base of the housing (4).
