SWAG 33 10 4727

To fit:
Range Rover (L405), Range
Rover Sport (L320, L494)

Additional water pump

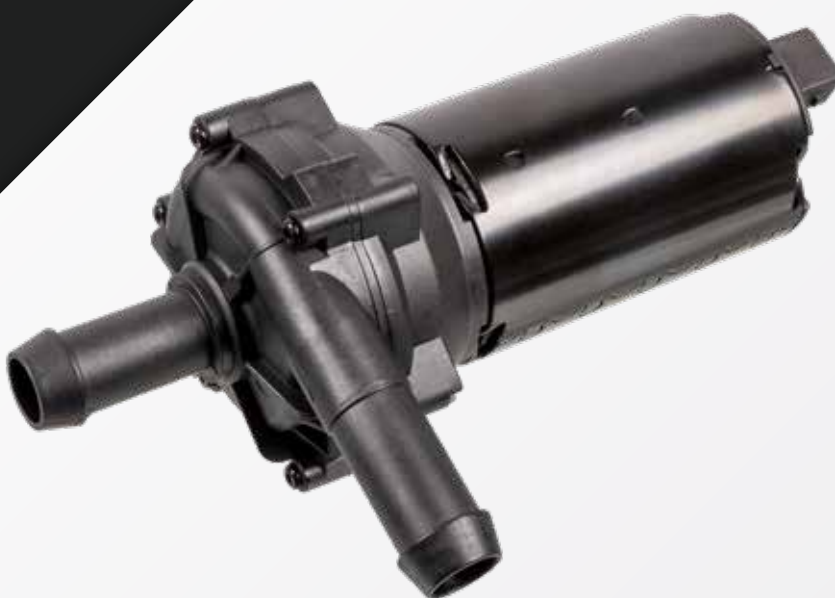
Reduced engine performance and/or cylinder misfire when under load and at high road speed.

The engine warning lamp is illuminated, related to the symptoms listed above.

On Range Rover (LM) Supercharged 6A198058 to 7A261419 and Range Rover Sport (LS) Supercharged 6A901924 to 7A109767 vehicles, the electrical harness positive supply and the negative within the connector C3006, for the auxiliary water pump, may have been manufactured incorrectly.

The two wires within the electrical connector for the water pump were wired incorrectly, causing the pump to run in the opposite direction.

The ECU will reduce engine performance to prevent damage to the engine because of the decreased coolant flow.

Using a voltmeter, check the positive and negative wiring orientation within connector C3006. If found to be wired incorrectly, use a terminal extractor tool and swap cavity 1 and cavity 2 wires to the correct positions.

The correct orientation for the Range Rover Sport (LS) is:

- Black (B) wire in Cavity 1 connected to negative pump connection
- Brown and Purple (NP) wire in Cavity 2 connected to positive pump connection

The correct orientation for the Range Rover (LM) is:

- Brown (N) wire in Cavity 1 connected to negative pump connection
- Red and White (RW) wire in Cavity 2 connected to positive pump connection

Afterwards, replace the auxiliary water pump and top-up the cooling system with the correct coolant. Clear any fault codes relating to the symptoms with a suitable diagnostic tool.
