**Loss of oil, loud noises, increased bearing clearance**

**Vehicle Manufacturer:** Mazda

**Vehicle:** Mazda 6 GG, GY, MPVII (LW)

**Engine Code:** RF5C

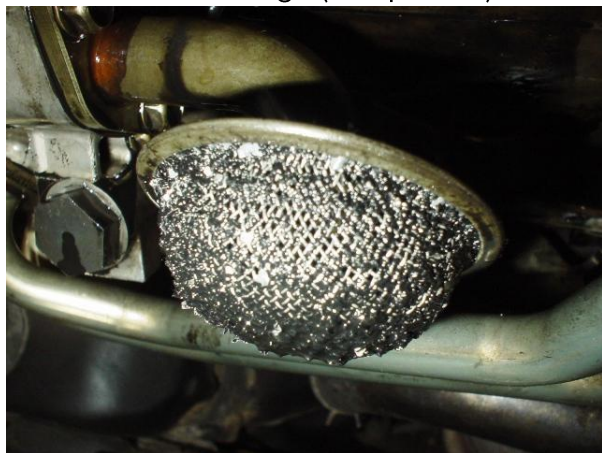
When exchanging the turbocharger, the oil strainer of the oil pump inside the oil pan should be checked for oil sludge (see picture).

Through loose or loosened as well as leaking injectors, soot may enter into the oil cycle and clog the oil strainer. This may lead to a damage of the turbocharger due to lack of oil or dirt particle problems in the engine oil cycle.

In addition, please check the injectors for any leaks and if they are fitted tightly to prevent the oil from getting dirtier.

Check if the injectors are fitted tightly and seal them up freshly if necessary.
