Lack of power, emergency program signal position sensor from actuator implausible

Vehicle: 307, 407, 508, 607, C4, C5

Engine code: RHR (DW10BTE4D)

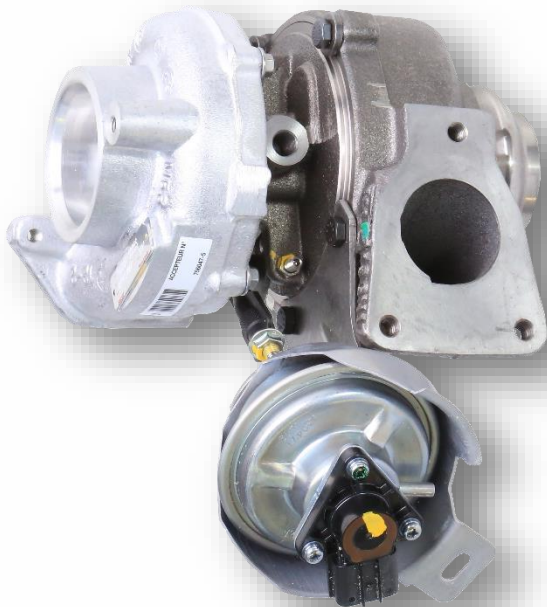
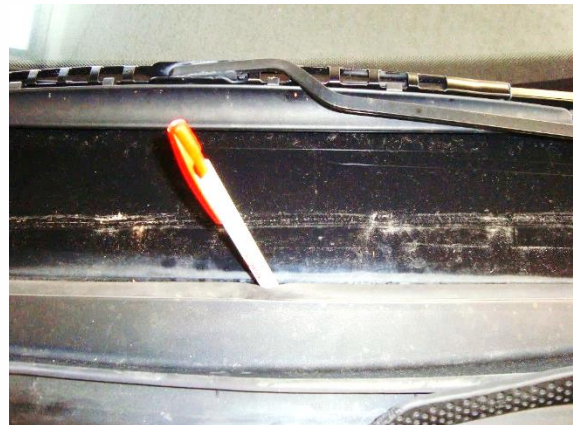
The vehicles suffer an abrupt power shortage as they fall into the emergency program. In the fault memory deviations of the position sensor of the boost pressure control on the turbocharger or a deviation of its signal voltage are stored.

About the aeration of the vacuum to the boost pressure control valve sucked water passes through the vacuum line into the control box of the turbocharger. There it comes to corrosion and failure of the position sensor.

When replacing the turbocharger, it is essential to replace the wastegate valve. All vacuum lines must be cleaned and checked for damage. Any filters on the open end of the ventilation pipes must be replaced.

It is essential to ensure that no spray water in the engine compartment and in particular a leak in the windscreen seal over the bulkhead passes on the control box or the open end of the ventilation tube from boost pressure control valve.
