Loss of boost pressure, noise at the turbocharger, exhaust-side foreign body damage due to EGR cooler

Vehicle: Movano, Master, NV400

BTS reference: T915586

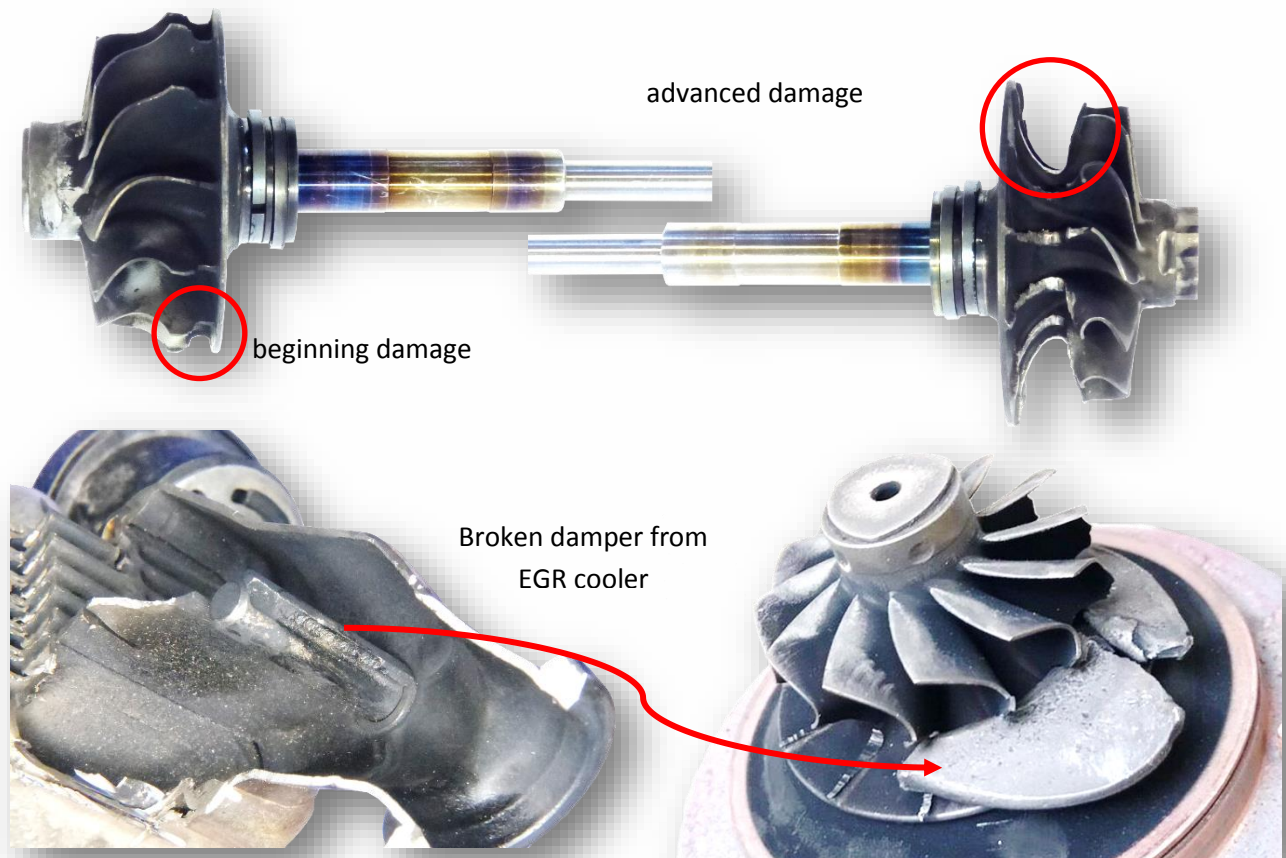
The fragment of the control flap in the EGR cooler is thrown back into the exhaust manifold during the load change. From there it will be blown with the exhaust gas flow into the turbine housing and destroys the gas inlet edges of the turbine wheel. It turns a performance loss with boost pressure error.

Check the complete EGR tract and exhaust manifold for foreign objects and damaged parts. In particular, the completeness and function of the damper in the EGR cooler should be checked. Damaged components must be replaced.
