### Lack of lubrication damage caused by clogged suction basket, softened toothed belts start laterally

# SI-191014

## Service-Information Turbocharger

**Vehicle:** Fiesta VI + VII, Focus III, Tourneo Conect, Transit Courier, B-Max, C-Max 1.0 EcoBoost

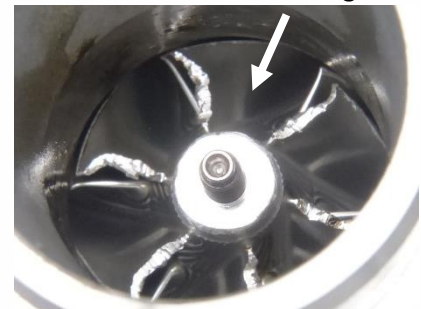
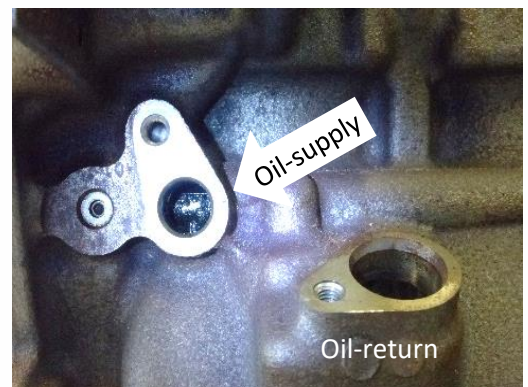
We find that many turbocharger failures on these vehicles are caused by a lubrication defect in the bearing of the rotor shaft. The lack of lubrication leads to a massive bearing damage with knocked out bearing. Ideally, the damage would be with a discarded nut on the rotor shaft and concomitant intake-side foreign body damage.

Rotor shaft nut is missing !

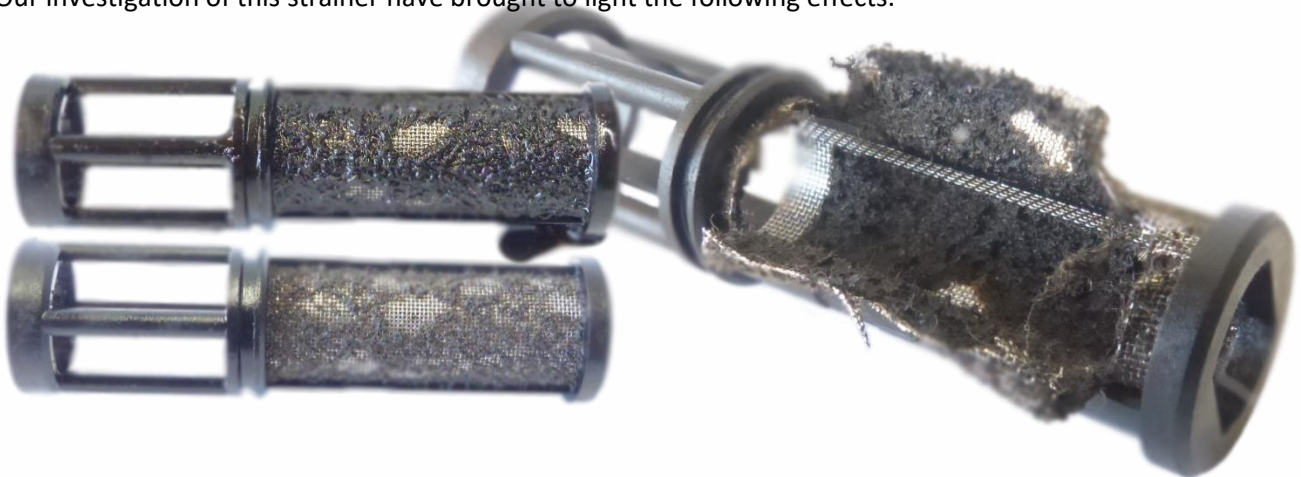
The timing belts soften and lose their stability. These start inclined to run and roam with considerable force at the flanged wheels of the toothed wheels. As a result, the timing belts wear on the flanks and teeth. The abrasion is then found in the oil circuit. Initially, fine fibers accumulate in the strainer of the oil suction basket of the oil pump and clog it increasingly. As a result, the recoverable amount of oil is reduced and the oil pressure drops. Before the oil pressure monitoring by the oil pressure switch becomes active, the turbocharger succumbs to the lubrication defect described. The failure of the turbocharger then prevented a major engine failure.

Our investigation of this strainer have brought to light the following effects.

It is recommended to rinse the strainer with as little spray pressure as possible. If the strainer shows over the entire surface as a shiny metal strainer, then there should be no obstructive impurities. But if stubborn blockages remain as a visible residue, then the utmost caution is required.

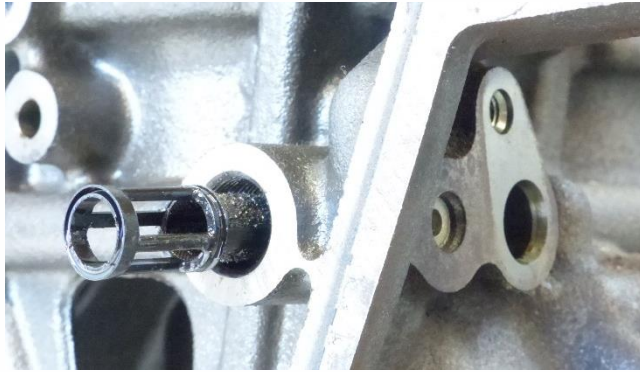
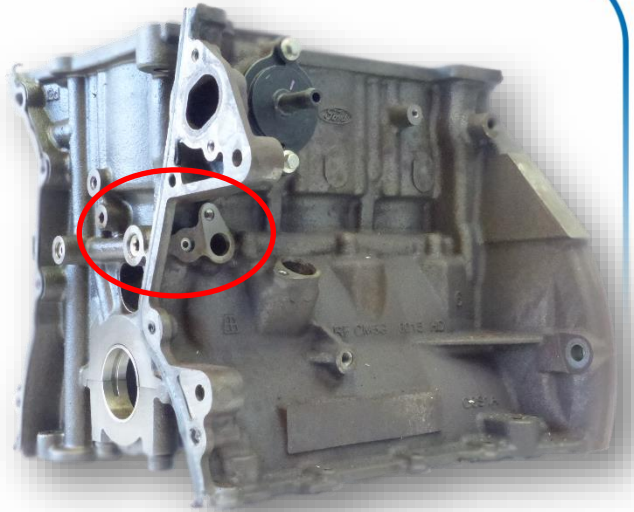
Even if the strainer in the oil supply should be free from contamination, the following defects are not excluded.

Before installing a new turbocharger, check the oil sump of the oil pump for contamination. Further, both timing belts should be checked for wear on the flanks and teethes. In case of damage, renew the oil pump, the two toothed belts and the strainer in the oil passage to the turbocharger according to the manufacturer's instructions. An oil flushing is recommended.

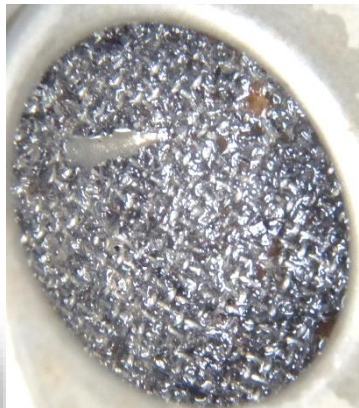
suction basket from below

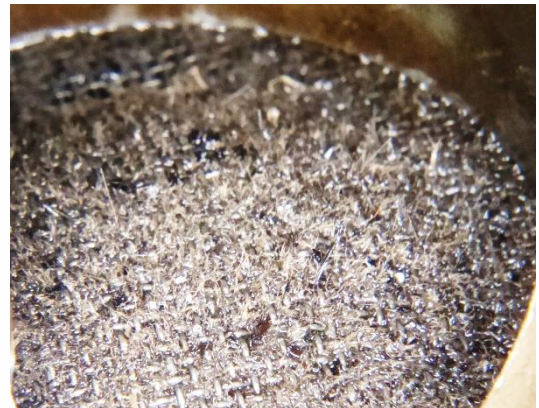
Inside of the suction basket
