"Electrical actuator failure" after ignition ON
requires action code from the vehicle manufacturer!

Vehicle Manufacturer: Audi, VW, Skoda, Seat
Vehicle: 1.2 TSI, 1.4 TSI / TFSI, 1.8 TSI
Motorcode: CBZA, CBZB, CBZC

BTS reference: T914898, T916401

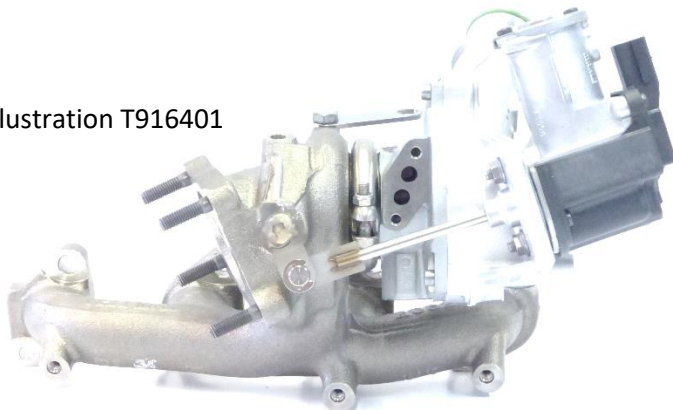
Illustration T916401

Whether an update of the motor control software is necessary in the course of an action code is shown after resetting the teach-in values and when teaching the actuator. If the "Error in electrical actuator turbocharger" is set in the fault memory after the ignition is ON, the problem is not a defect in the turbocharger, but the need to carry out a software update with activation of the adaptation according to the action code.

**Observe and implement the
vehicle manufacturer's
action code**
