Turbocharger with different position sensors leads to malfunctions if interchanged

Vehicle Manufacturer: FORD, CITROEN, PEUGEOT

Vehicle: 1.4 HDI, 1.6 HDI, 1.5 TDCi, 1.6 TDCi

BTS reference: T915913, T918323 **BTS-Service-Set-Nr:**

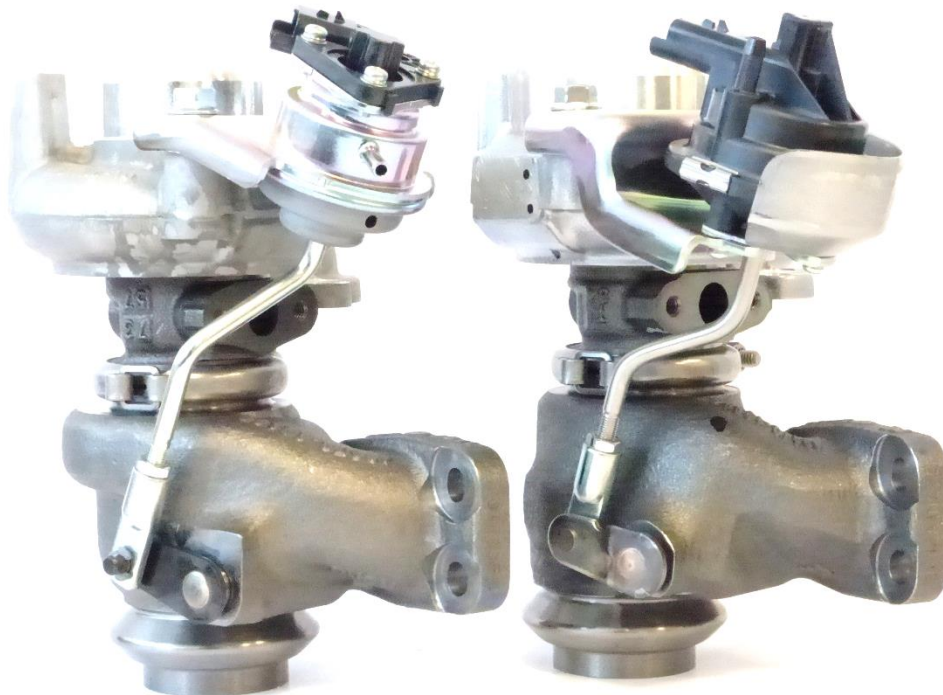
These turbochargers cannot be replaced, even if the connector on the vehicle side can be plugged in. The turbochargers differ in the signal voltage values of the position sensor. Incorrect application results in fault memory entries and emergency running function.

The distinguishing feature is the vacuum actuator with position sensor.

T915913 (49373-02013)

T918323 (49172-03000)

Before starting the assembly work, the turbocharger supplied has to be compared with the old part. The check has to be carried out before filling the turbocharger with the initial filling additive.
