# FITTING INSTRUCTIONS

## Transmissions systems

**Model for**  
Opel  
(gearboxes M32 &  
M20)

**Part numbers**  
804578 810016 810017  
810034 810039 810068  
810226

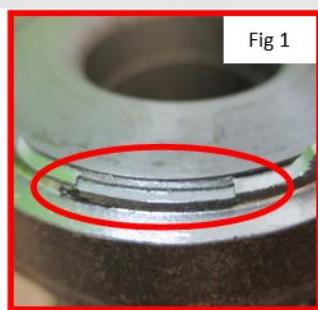
1. Before fitting the unit, **ensure the gearbox mating face is clean and clear from debris**. If it is not this can cause the unit to **sit unevenly on the gearbox (Fig 2)** giving the potential for the back plate to be **forced out by the hydraulic pressure (Fig 1)**.

Unit returned has the back plate forced out; this is caused by the back plate not being supported by the gearbox mating face.

Ensure the gearbox mating face is clear from debris and the unit is sitting flush before tightening the bolts.

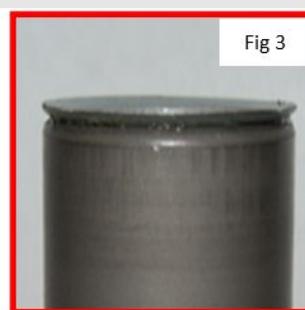
3. Check the hydraulic line for any defects or blockages. If the clutch pedal goes hard or does not return to its resting position after each depression during the bleeding process, **do not continue to try to bleed the hydraulic system**. Continuing to do so will result in too much fluid entering the fluid chamber within the CSC and will cause the piston retaining ring to move past its stopping point. **In Fig 3 you can see deformation/rippling. This shows that the cylinder has been over stroked.**

The piston retaining ring has deformation or rippling. This shows that the cylinder has been overstroked.

**If the clutch pedal becomes hard, DO NOT depress the pedal further!**

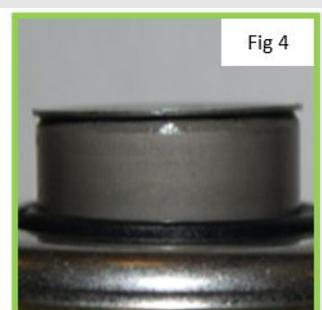
The piston retaining ring has no deformation or rippling. This shows that the cylinder has not been overstroked.

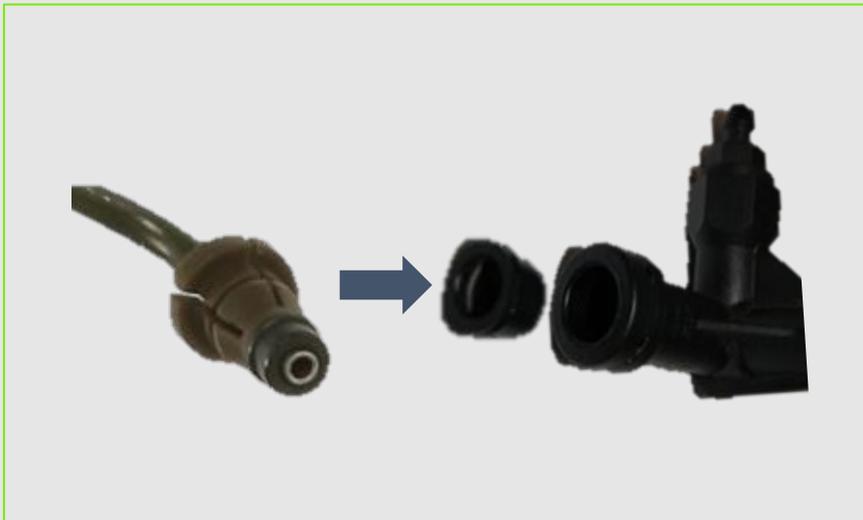
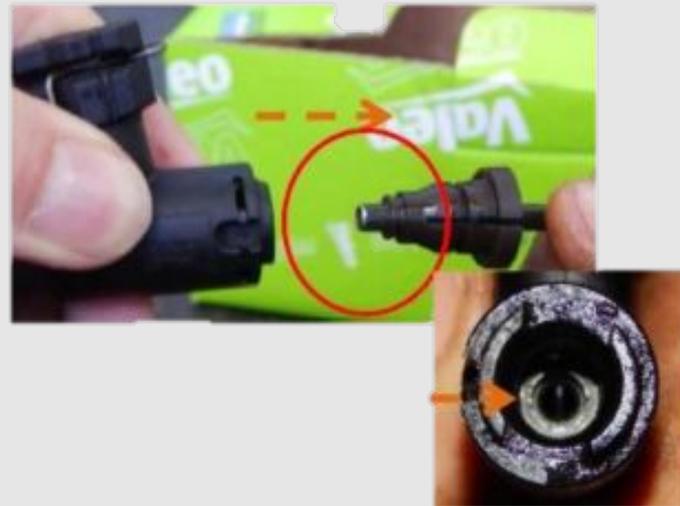
This issue is caused by a top hat seal located on the inlet/actuator pipe remaining in the female connector when the old unit is removed and/or the technician fit the new seal in the new CSC keeping old seal and new seal, this creates:

- A **one way valve situation** allowing fluid into the internal CSC chamber but not allowing it to return.
- **Over pressure** creating liquid leak and CSC breakdowns
  - The **fluid does not return**, too much fluid in the CSC will cause the bearing to over travel and force it past its end position and beyond the CSC retaining ring.

Subsequent depressions of the clutch pedal will fill the CSC until its full travel and a stiff pedal will occur. If this stiff pedal is overcome the CSC will over stroke and burst, necessitating a replacement.

**Ensure you removed the old seal from the pipe!**
