Technical *Info*

Pulley failure as a result of incorrect installation of the tensioning spring – CT 738 K1 (Mitsubishi, Proton engine type 4 G, various models)

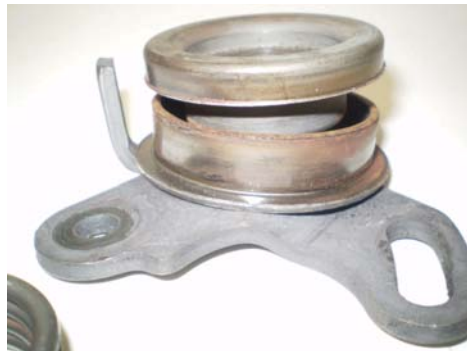
The belt drive fails because of a broken tensioning pulley.

The pulley has been split in the middle as a result of an unacceptable external action (spring contact).

Always check that the tensioning spring has been positioned correctly. Otherwise, dangerous contact can occur with the tensioning pulley's contact surface which is irretrievably damaged as a result.
