# Blue Print ADC49169

various Citroen, DS, Fiat, Ford, Jaguar, Lancia, Land Rover, Mitsubishi, Opel, Peugeot, Toyota and Vauxhall models

## Water pump with gasket

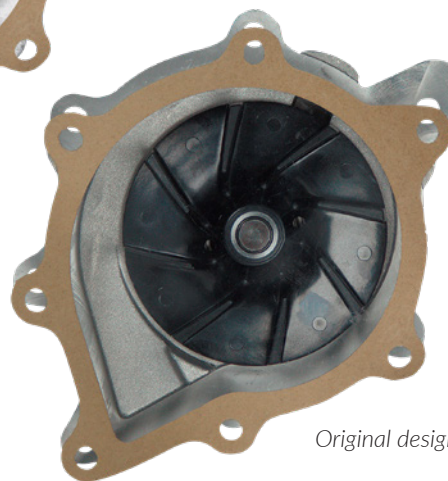
Original design

The original water pump impeller is made from plastic, which can become detached from the impeller shaft. Therefore, the water pump is turning with no effect and no coolant will flow around the cooling circuit of the engine.
