to fit:  
Mitsubishi various models, Proton various models

## TIMING BELT TENSIONER PULLEY

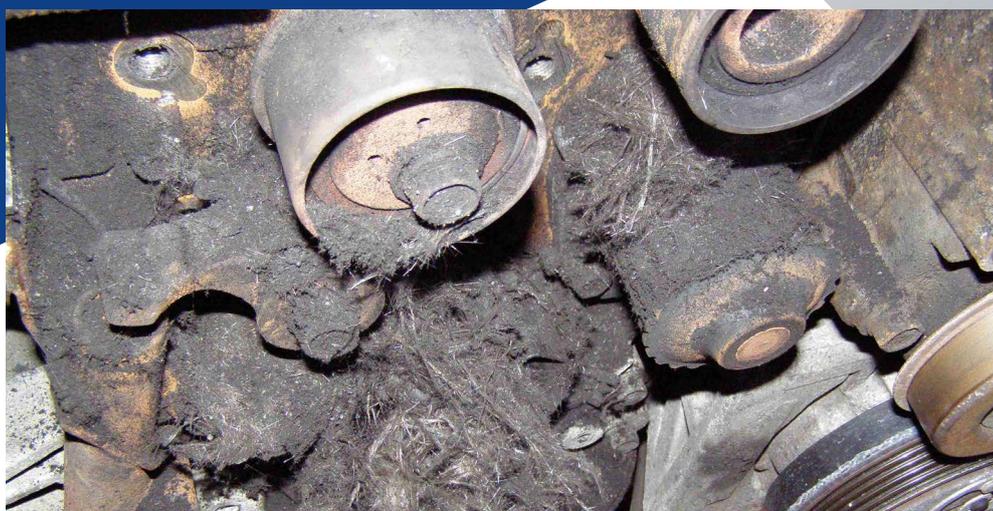
Fig. 1

Due to several claims of 'timing belt failure' on the above models, thorough investigation has identified the cause, as incorrect timing belt tensioner pulley operation, resulting from incorrect fitment. (Fig.1)

Special attention is needed when installing this belt tensioner pulley. Turning of the tensioner must be done in an anti-clockwise direction. If this is not done, it leads to incorrect tension and very often tensioner pulley seizure. The tensioner bracket touches the pulley, obstructing it, and preventing it from rotating freely. As the pulley cannot rotate anymore, the back of the timing belt constantly rubs against the pulley surface and starts to overheat and crack, leading to failure.

When replacing the timing belt and any associated parts the vehicle manufacturer's recommended intervals must be adhered to. The recommended fitting instructions must be followed, and any special tools must be used.

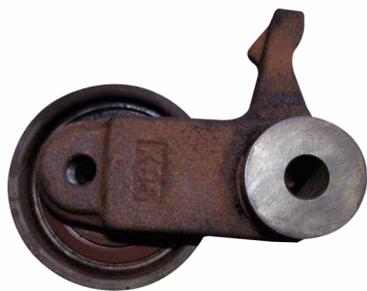
Fig. 2 - Correct Position

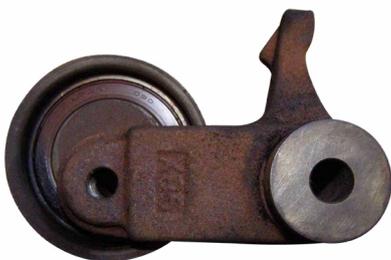
Fig. 3 - Incorrect Position
