SWAG 33 10 0266

To Fit: Various Volkswagen, SEAT and Škoda models equipped with the 1.4/1.6 MPI and TSi engines.

Heating Flange for intake air preheating

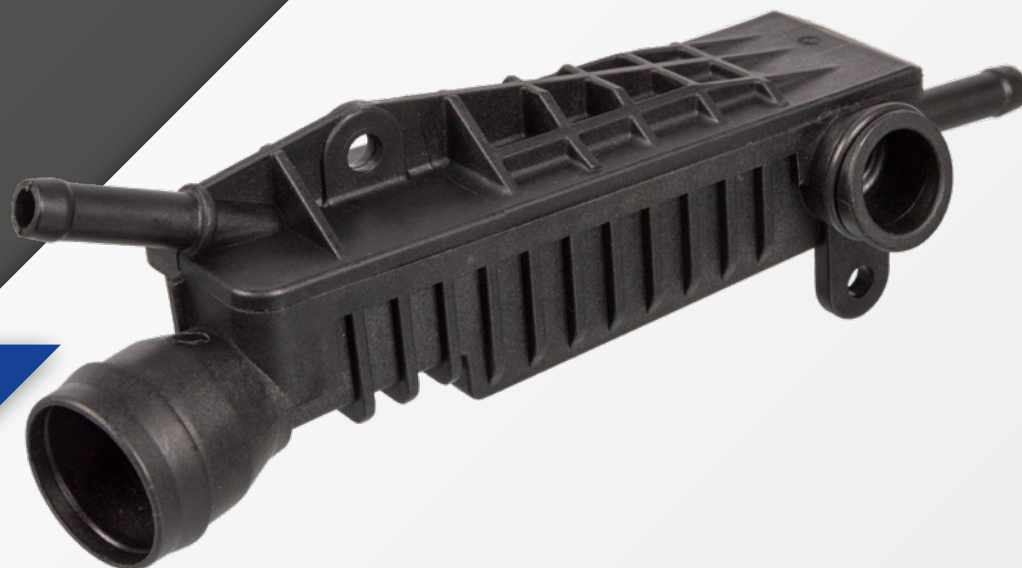
The 'low coolant level' warning indicator is illuminated due to a reduction in coolant. Upon inspection, a coolant leak is found to be coming from underneath the inlet manifold.

This part is made from a reinforced polyamide. However, due to the wide fluctuations in temperature it is exposed to within the engine bay, over time the seam between the two bonded sections becomes weakened. As such, when the cooling system is at operating temperature and pressurised, coolant leaks through this compromised seam.

This component is attached to the underside of the inlet manifold by two screws. Therefore, it is recommended to first remove the inlet manifold to gain access to replace it.

Remove the faulty heating flange, replace any other necessary gaskets and connecting hoses if required, and then refit the manifold. Top up the cooling system with fresh coolant and recheck the integrity of the system.
