SWAG 33 10 6704

Nissan Dualis 2007 > 2014, Note 1 2006 > 2013,
Pathfinder 3 2005 > 2014, Qashqai 1 2006 > 2014

Clock Spring

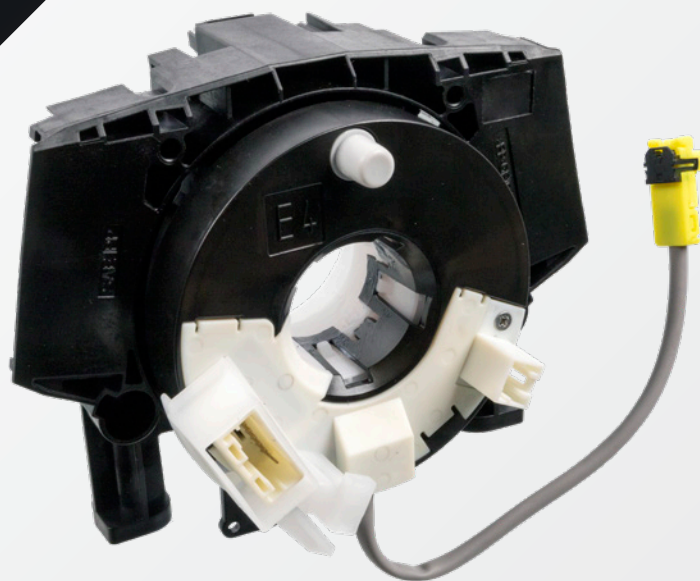
Upon starting the vehicle, the airbag warning light stays illuminated and there is a partial or full loss of functionality of steering wheel controls such as the horn or cruise control. Using a suitable diagnostic tester, the airbag control unit shows the fault code B1049 - 'drivers side front air bag igniter circuit/open circuit open'.

A coiled strip cable inside the clock spring results in constant contact being made between the wiring loom and the moving components on the centre of the steering wheel. Constant movement and climatic variations can cause fatigue, which ultimately leads to failure of the clock spring.

- Disconnect the battery and wait at least two minutes before starting work on any part of the airbag system.
- Make sure that the steering wheel is in the 'straight ahead' position.

- Remove the airbag module from the steering wheel. There are two holes on the reverse of the steering wheel; one on each side. Insert a blade-type screwdriver into each hole to release the internal clip and gently pull the airbag unit until it is free. Disconnect the yellow electrical connector and the connector with a green wire. The airbag module can now be placed in a safe location with the pad side facing upwards.

- Before removing the steering wheel, make sure that the indicator mark on the steering column is aligned with the 'V' marked on the steering wheel. If you cannot see these indicators, it is advised to add the marks yourself - this will make it easier to align when refitting the steering wheel later.

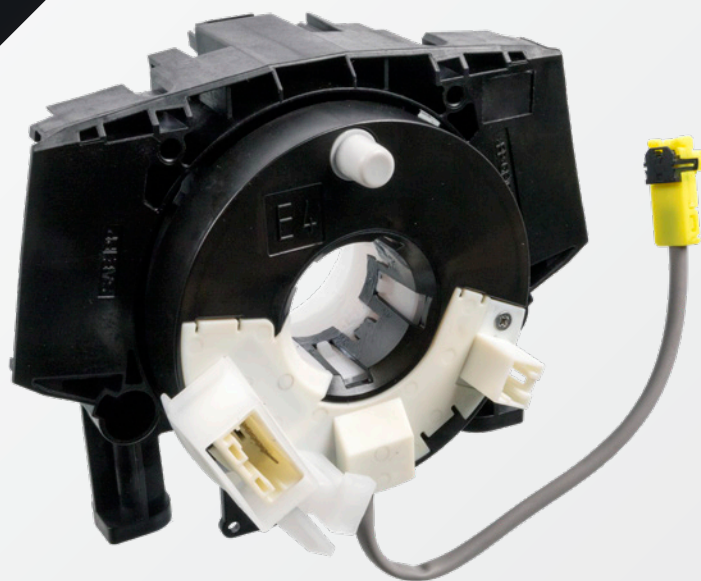
Clock Spring (continued)

- To remove the steering wheel, take out the 19mm nut holding the steering wheel in place.
- Unscrew the three screws holding the shroud. Carefully 'part' the shroud, allowing access to the steering column.
- Remove the two multi-function switches by squeezing the top and bottom clips.
- Remove the two screws holding the clock spring to the steering column. You may need to release a wire clip at the top to fully release the unit and disconnect the electrical connectors from the back of the unit, with the grey connector disconnected first.
- Before fitting your new SWAG 33 10 6704 clock spring, you will need to transfer the steering-angle sensor (marked as 47945-JD000/JD00A) from the old clock spring. This is held in place by two screws.

- Firstly, reconnect the yellow electrical connector to the clock spring - this interconnects with the grey one next to it.
- When the clock spring is attached to the steering column, remove the transportation lock.
- Refit the steering wheel, making sure that it is aligned correctly with the shaft. Feed the wires through the steering wheel.
- Tighten the steering wheel nut to 34 Nm.
- Refit the air bag unit.
- Reconnect the battery.
- Clear the fault code from the ECU and retest.
- To ensure that the correct level of resistance is maintained, it is advised that a small amount of dielectric grease is used on all electrical connections of the clock spring.
