SWAG 33 11 0226,

Mazda 3 (BL) 08-14, 6 (GH) 07-13 and CX-7 (ER) 06-14 equipped with the 2.2 CiTD diesel engine

Timing Chain Kit

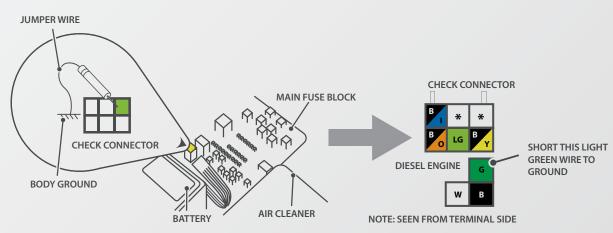
Mazda 6 (GH)

Short the connection between the terminals of the check connectors terminal using a jumper wire as per diagrams below for each model.
