## SWAG 60 94 7222

Various Renault models fitted with a JB or JC manual transmission

## Gear Selector Lever Repair Kit

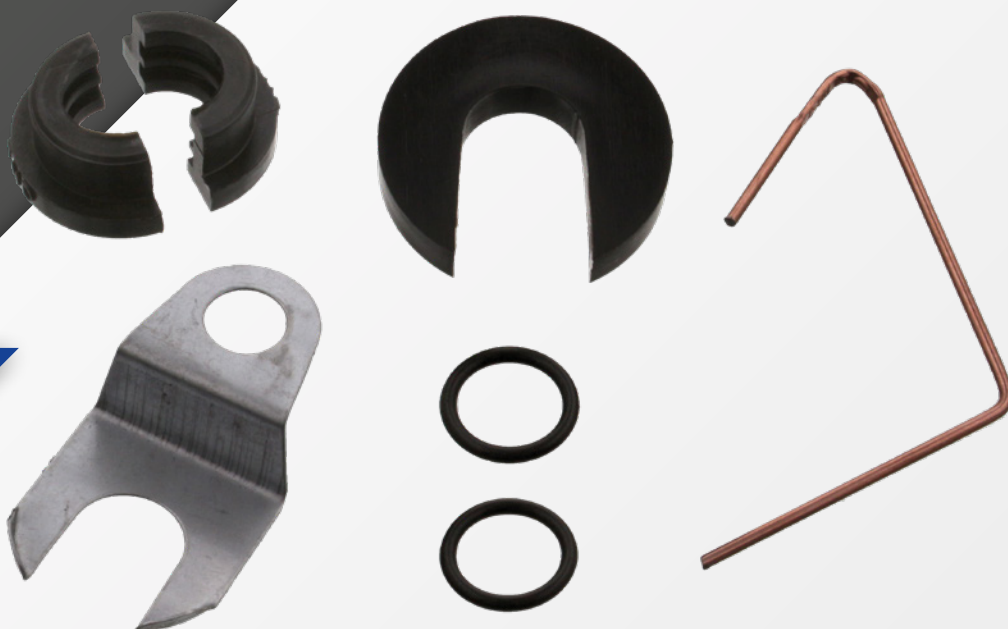
The repair kit 60 94 7222 offers the option of sealing the shaft using two half shells and two O-rings. This significantly reduces the time required for this repair as the gearbox does not need to be removed in order to carry out this repair.

The repair kit comprises of:

- Two rubber O-rings
- A wire which is used to pull the rubber O-rings over the gear lever and onto the shaft
- Two half shells
- A plastic plate which is used to drive the two half shells together with the inserted rubber O-rings into the opening
- A metal plate
