## SWAG 10 93 8868

to fit:  
Mercedes Benz W204, W207 and W172

## Shaft seal with ABS impulse ring

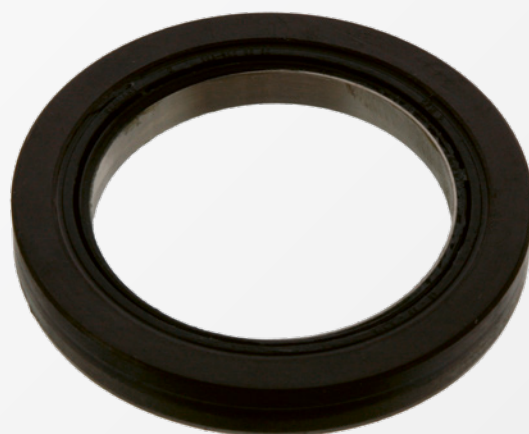
The original version (Repl. no. 203 330 0060) of the shaft oil seal has no rotating collar (Fig. 1). The stub axle surface becomes corroded and worn, resulting in the running surface of the shaft seal to become uneven and eventually causing failure of the shaft seal.

The manufacturer has provided the shaft seal with a rotating collar (see arrow, Fig. 2). The stub axle and the front wheel hub are not affected by this change. SWAG recommends replacing the shaft seal with the most up-to-date version (Fig. 2). Due to optimisation of the shaft seal, it is no longer necessary to replace the stub axle if the running surface is damaged slightly, the rotating collar serves as a substitute for the stub axle's running surface.

The rotating collar is preassembled in the shaft seal and must not be removed under any circumstances. If the front wheel hub is dismantled (Fig. 3), the rotating collar (where present) generally detaches itself from the shaft seal and has to be removed from the stub axle separately.
