**SI 0083**  
For technical personnel only!  
1/2

# SERVICE INFORMATION

## QUICK INSPECTION OF SECONDARY AIR VALVES

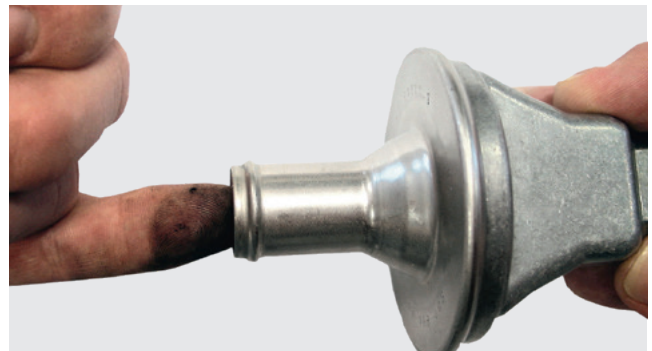
Damage as a result of exhaust gas condensate

The new condition as a comparison

Fig. 1: Simple inspection of the non-return valve

- Loosen the connecting hose on the secondary air non-return valve leading to the secondary air pump.
  - See inspection point “P” on the graphic overleaf
- If there are deposits on this side of the valve (finger test, see Fig. 1), the nonreturn valve is leaky and must be replaced. In that case the secondary air pump may already have been damaged.
- Inspect the secondary air pump and replace it if necessary.

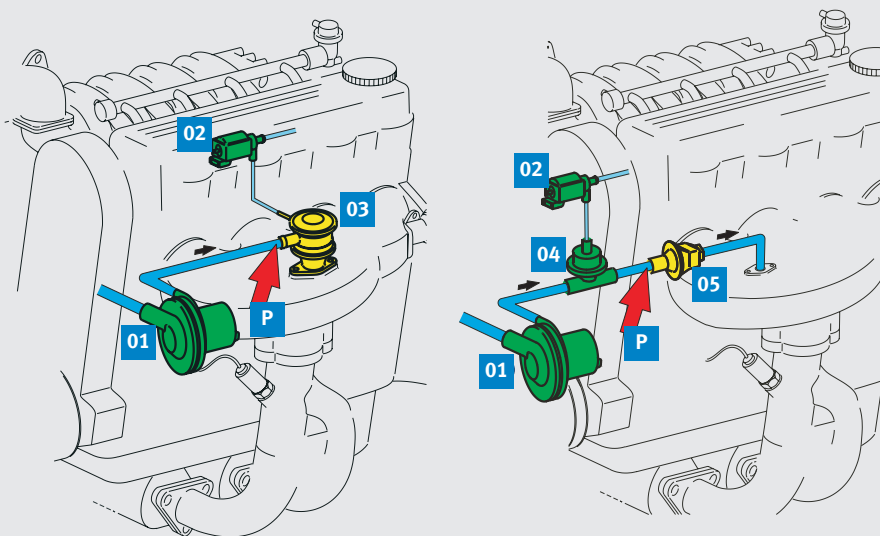
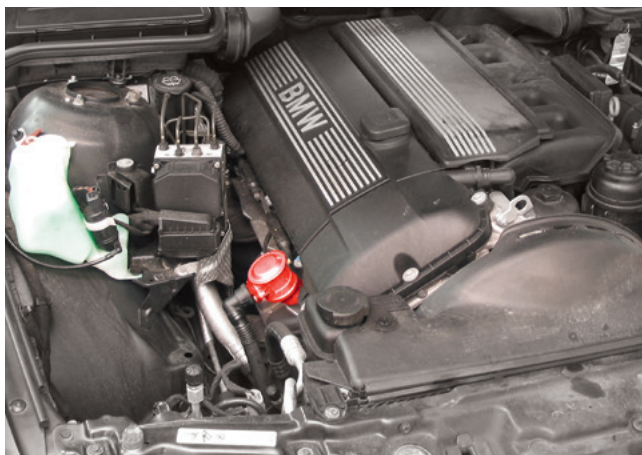
- 01 secondary air pump
- 02 electrical reversing valve (EUV)
- 03 switch-off non-return valve (approx. 1995 →)
- 04 secondary-air switch-off valve (approx. 1993 → 1997)
- 05 secondary-air non return valve (approx. 1993 → 1997)
- P inspection point for quick inspection

Two variants of the secondary air system

Secondary air valves are an integral part of the secondary air system. They are fitted between the secondary air pump (1) and exhaust manifold.

They prevent pressure peaks in the exhaust flow from damaging the secondary air system and exhaust gas or condensate from entering the secondary air pump. There are different designs of secondary air valves:

Switch-off non-return valves (3) are generally vacuum-operated valves. Later designs (from approx. 1998 →) are opened by the pressure of the secondary air.

This does away with pneumatic control by an electrical reversing valve (2).

Secondary-air non-return valves (5) open as a result of the pressure of the secondary airflow.

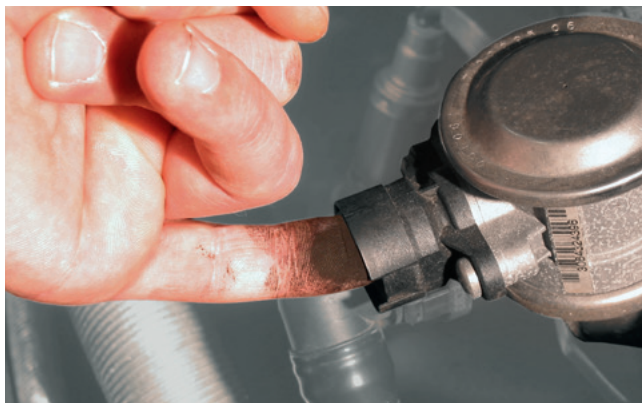
Quick inspection of the secondary air valve in the BMW 520i (highlighted)
