# SWAG 10 92 6775

to fit:  
Mercedes Benz CDI engines

Repl. No. 646 200 05 70

## Belt tensioner

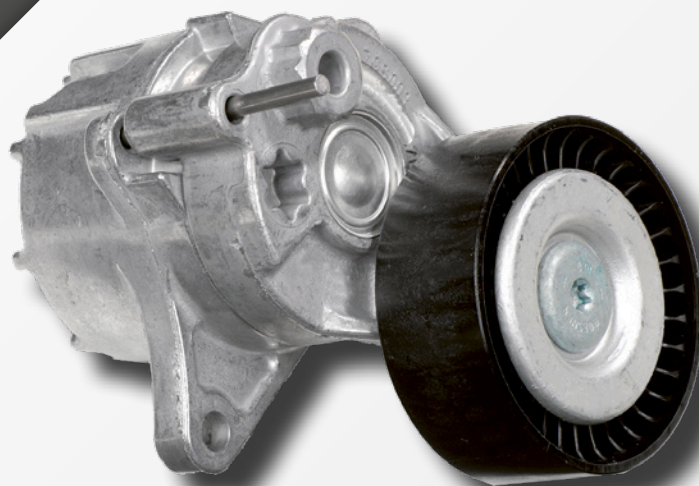
The noise is generated because the spring is too long and makes direct contact with the base of the housing (1). Only the spring's torsional characteristics are important for this application (2), (6).

The noise is caused when the spring touches the cast-in hollow pin (3) and the base of the housing (4).

A highly wear-resistant plastic bushing (5) distance the spring from the base of the housing and prevents metal-to-metal contact where the spring is located. Since only the springs' torsional characteristics are important the height has been reduced (6).

The spring makes contact with the plastic bushing (7) and is therefore prevented from touching the base of the housing. No noise can therefore occur. In the new version (8), a steel pin has been cast in the base of the housing in order to center the spring.
