# NEW PRODUCT HIGHLIGHT | APR2022 SWAG 33 10 3243

Engine: 2.0 CDTI

### Inlet manifold with swirl flap actuator and gasket

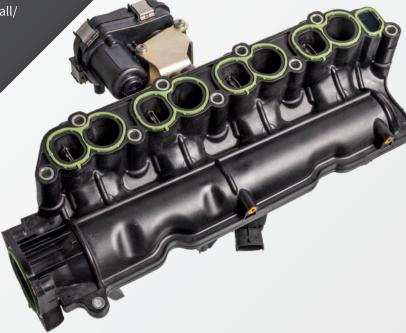
The main purpose of the inlet manifold is to evenly distribute the intake air charge into each intake port of the cylinder head. Swirl flaps are fitted to the intake manifold, close to where it connects to the cylinder head. The positions of the flaps are controlled by an actuator, depending on the engine speed and load. The swirl flaps are closed at idle speed and gradually open as the engine speed increases, until reaching the fully-open position (parallel to the direction of airflow). This introduces turbulence into the intake charge, creating a good air/fuel mix at low-to-mid engine speeds - which in turn helps to reduce vehicle emissions.

Exhaust gases from the EGR system mix with oil vapour from the crankcase ventilation system, causing oily deposits to form inside the inlet manifold. These deposits harden, restricting the operation of the swirl flaps and putting strain on the spindles. Eventually the shaft will cease to move if it is not replaced.
