SWAG 30 93 8238

To Fit:
Various Volkswagen, Audi, Seat,
Skoda and Mitsubishi models

Crankshaft Oil Seal

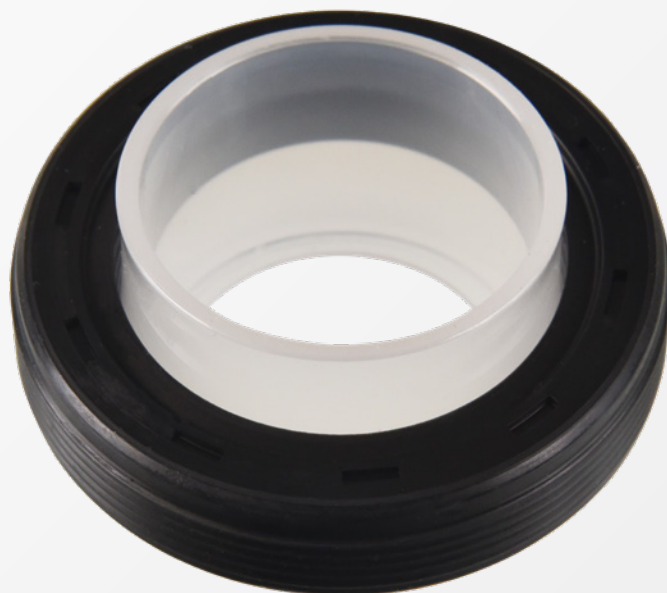
Oil leak after replacement of the crankshaft seal.

When installing this sensitive seal, the sealing lip is easily damaged and the seal does not function correctly.

The SWAG 30 93 8238 crankshaft seal comes complete with a special installation adapter. This is provided to avoid damage to the seal during installation.
