SWAG 33 10 1419

To fit:
various Mercedes-Benz models, W204, W212,
W172, W906, W639, W166, plus other models
equipped with the OM651 engine

Coolant Flange with fuel filter holder

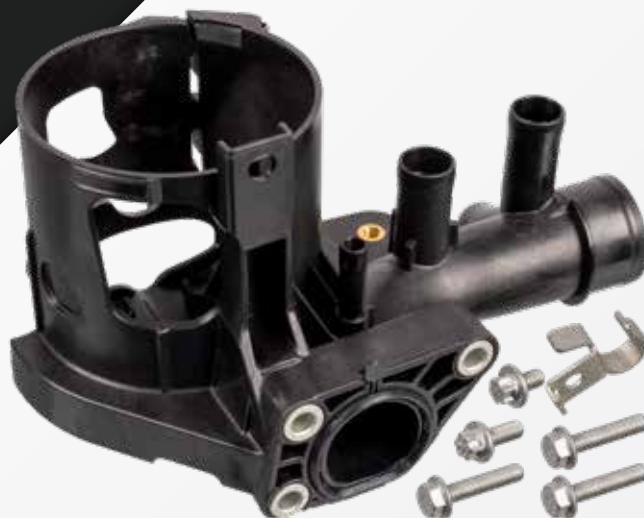
There is coolant loss from the inlet manifold area.

The connection outlet incorporating the fuel filter housing warps due to being continuously exposed to heat cycles and vibration when the engine is operating. Over time, the connection to the cylinder head weakens, leading to a poor seal to the engine and, in turn, a coolant leak.

The new SWAG part 33 10 1419 has been produced from a reinforced glass fibre polyamide which has an improved and strengthened connection to the cylinder head and all necessary fixing components.

Firstly, drain the cooling system and remove the EGR cooler to gain access to the housing.

Do not open the fuel system, if not required, because there are known examples of 'air locks' after a repair which prevents engine start-up. If the fuel filter is removed or replaced, carry out a fuel system activation of the low-pressure pump. To do this, switch the ignition on for approximately 5 seconds and then switch it off again - repeating this bleeding procedure 5 to 6 times before attempting to crank the engine.

Remove the old housing and discard of it. Ensure all mating surfaces are clean before fitting the new housing.

Replace the fuel filter housing and tighten the bolts in sequence.

Finally, refill the cooling system with fresh coolant and bleed the system of any excess air.

Note: For engines with only two threaded holes in the cylinder head, attach the new housing using the two-diagonal opposed fixing holes.
