SWAG 60 93 3986

To fit:
Renault Clio 3, Modus

Engine: K9K
Gearbox: JA5, JR5

Engine mounting

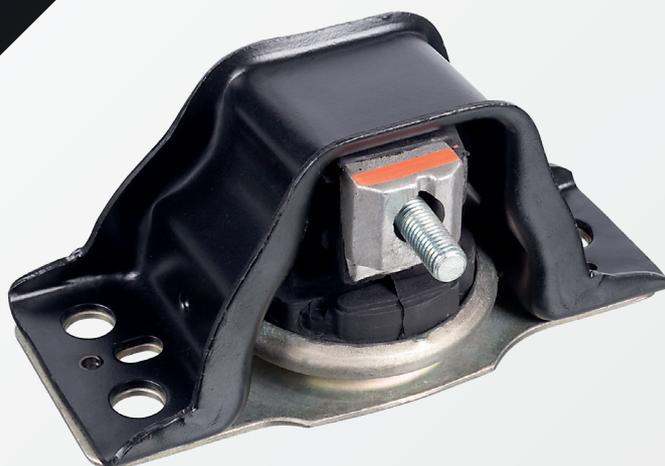
When the vehicle is in neutral with the engine idling, a vibration/judder can be felt through the vehicle dashboard, accelerator, brake, clutch pedal and seat. Additionally, a 'humming' noise can be heard.

When exposed to the elements and hot and cold heat cycles, the engine mount's rubber component begins to degrade. In turn, this degradation causes excessive movement of the engine mount.

Make sure the vibration is being caused by the engine mount by increasing the engine speed to see if the noise disappears or changes tone.

Get the help of an assistant; they can manipulate the mounting by adding pressure to it using a lever bar, which applies a load to the engine mount in several areas. If the noise disappears, the mounting should be replaced.
