SWAG 70 10 4235

to fit:
Fiat 500, 500C and Panda models

Brake Hose

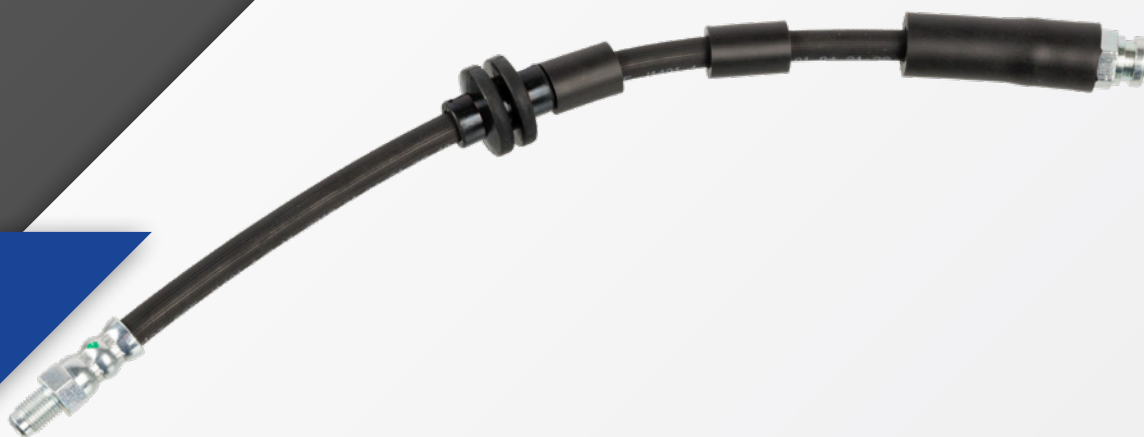
The front flexible brake hose is prone to corrosion where the steel union connects to the rubber hose. A rubber sleeve that covers the lower part of the metal union and the top of the rubber hose is positioned against the bracket which attaches to the steel brake pipe. This rubber sleeve traps dirt and moisture from within the wheel arch which causes the steel components of the hose to corrode. This results in severe weakening of the brake hose which can fail when pressure is applied during braking.

It is advised that during scheduled maintenance, the brake systems on the vehicles listed above require special attention to include the inspection and replacement of the front brake hoses which have signs of corrosion affecting the metal unions.
