Neu bei METZGER:
Ölstopp-Kabel für Anschlussleitung
Nockenwellenversteller Mercedes-Benz: A 271 150 27 33

Oil stop cable for connecting lead camshaft adjuster
Mercedes Benz: A 271 150 27 33

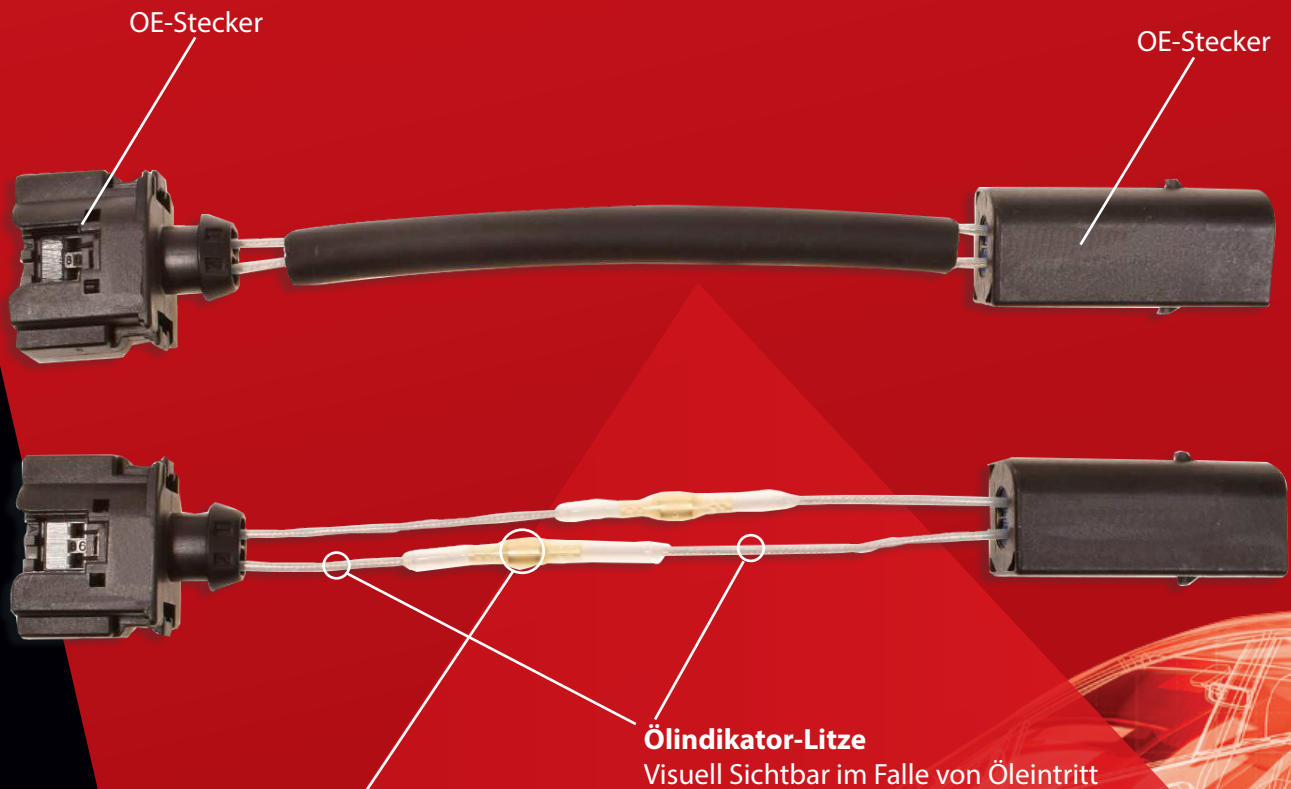
Innovation: Ölstopp-Steuerungsverbinder Ölindikator-Litze

Der Ölverlust am Nockenwellenversteller ist bei bestimmten Mercedes-Benz Motoren ein bekanntes Problem. Durch die Kapillarwirkung kann das Öl im Kabelbaum bis zum Steuergerät gelangen. Dies kann zum Ausfall der Elektronik führen. Durch das Metzger „Ölstoppkabel“ wird ein Eindringen von Öl in den Kabelbaum wirksam verhindert.

Ölstopp-Steuerungsverbinder

- Korrosionsfrei
- Verbindungstechnologie gemäß
 - Norm DIN EN 60352-2
 - VW Norm Group Standard VW 60330

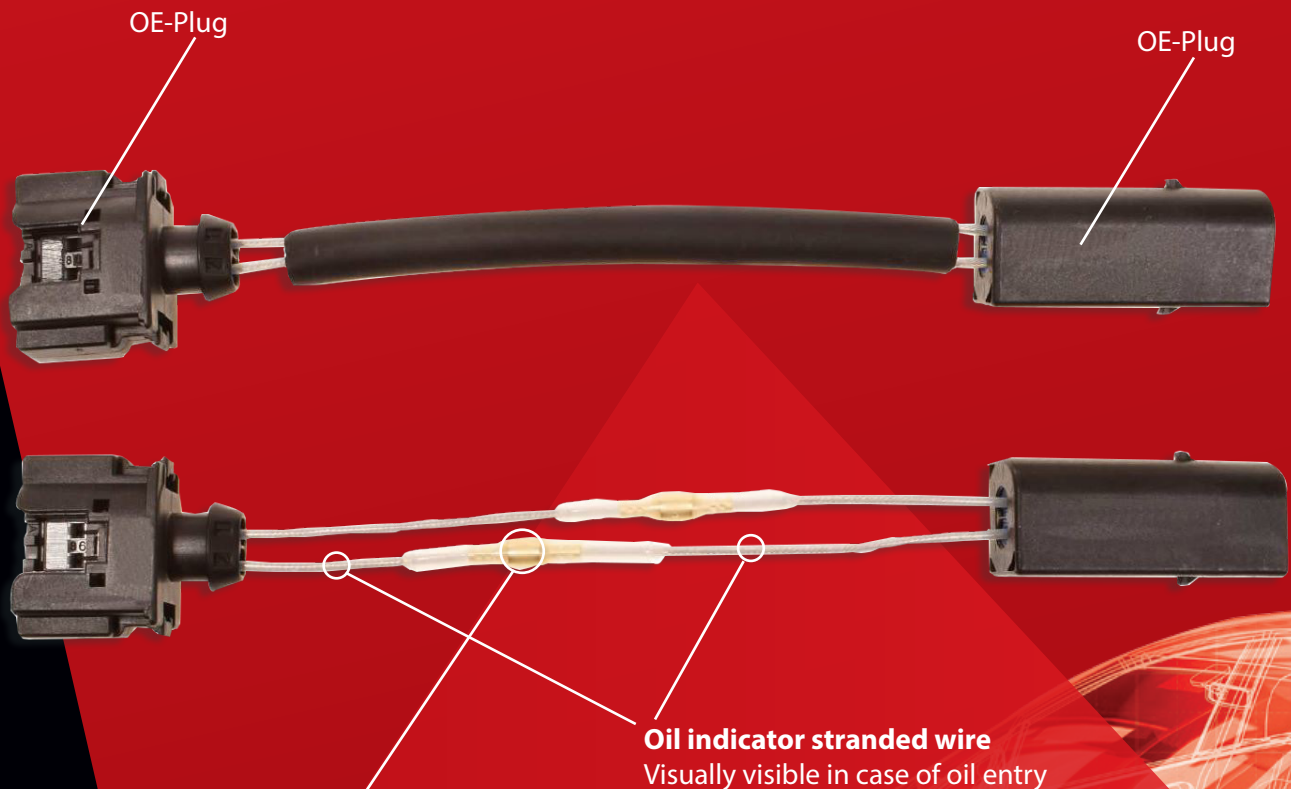
Oil stop line connector

Oil indicator stranded wire

The loss of oil at the camshaft adjuster is a known problem with certain Mercedes-Benz engines. Due to the capillary effect, the oil in the wiring harness can reach the control unit. This can lead to failure of the electronics. The Metzger's „oil stop cable“ effectively prevents oil from penetrating the wiring harness.

- Corrosion-free
- Connection technology according to
 - Standard DIN EN 60352-2
 - VW Norm Group Standard VW 60330
